Roaring Lion Fire - Assessment of Private Land Fuels Mitigation

Adapted from: Byron Bonney, Community Forester- Bitter Root RC&D

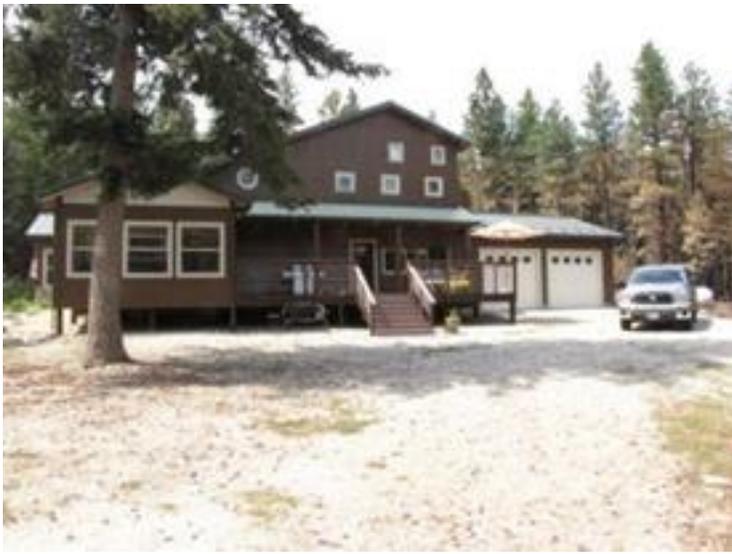
Figure 1: Residence did not have any burnable vegetation near the house. The deck had rock underneath the composite decking. It had a metal roof and cement board siding and a gravel driveway surrounded the house on two sides. Trees were cleared away from the house.

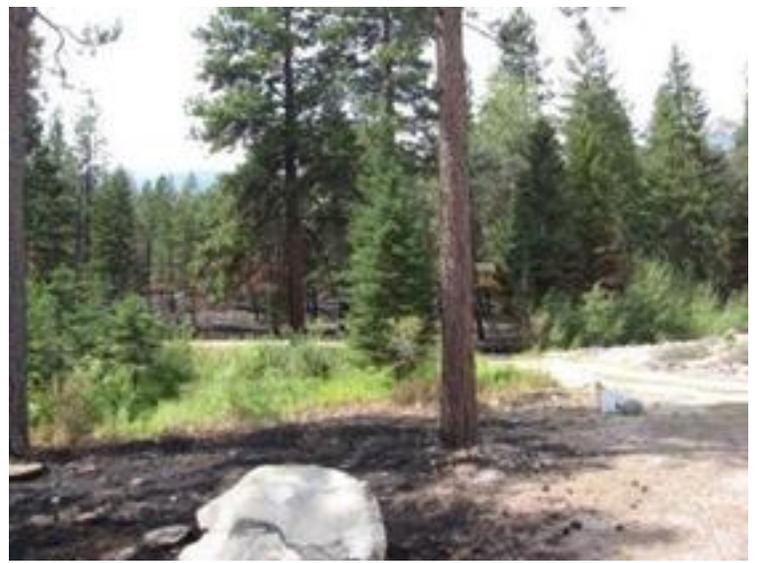
Figure 2: Riparian area south of house had minimal impacts from the fire. Note the burned surface in the foreground.

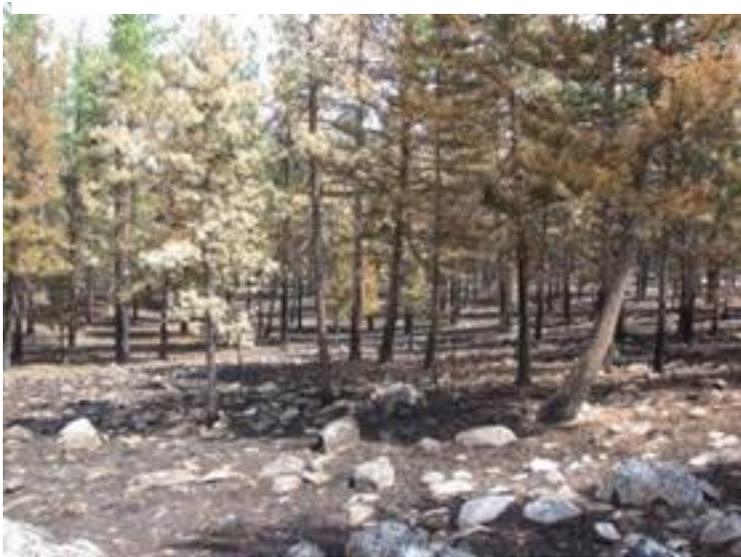
Figure 3: Timber stand where the surface fire burned across the property. Very minimal amount of torching but most of the Doug-fir had a significant amount of scorch.

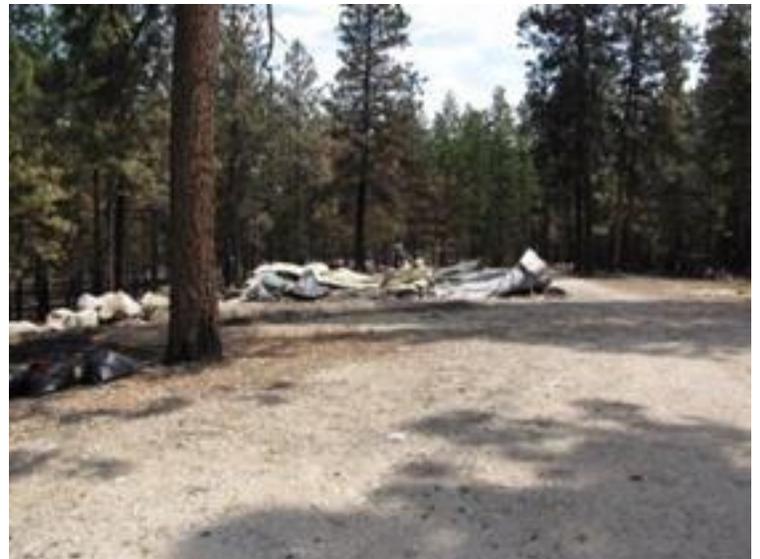
Figure 4: The site of the garage that was destroyed by the fire. It was about 200 feet east of the house.

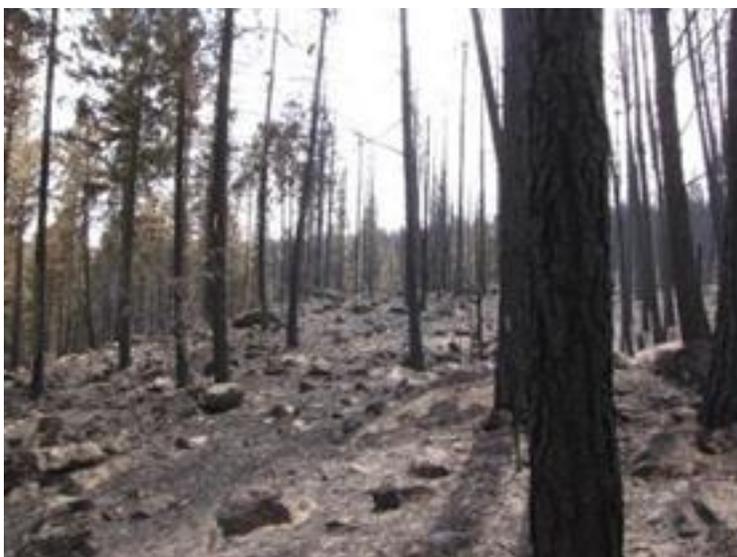
Figure 5: Neighboring area that had a very intense active crown fire. When the fire burned onto this property, it transitioned to a surface fire, under-burning the thinned stand as shown in Figure 6.

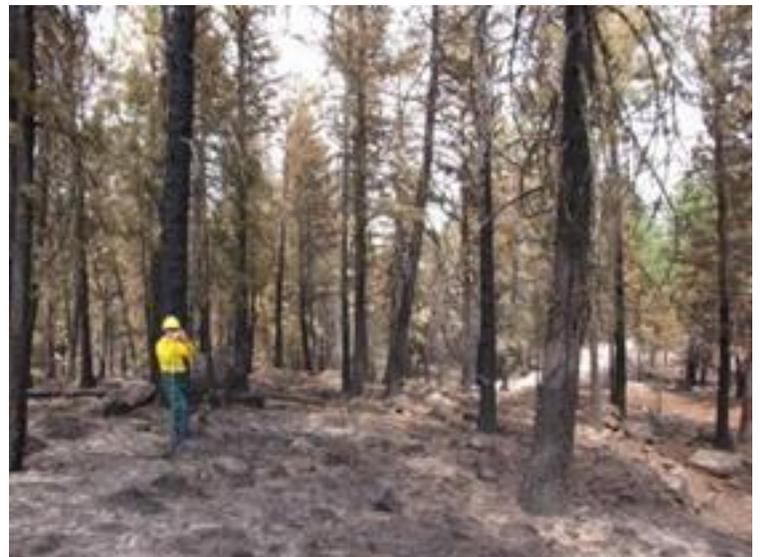
Figure 6: Below the crown fire where it had transitioned to a surface fire.
